The Department of Environment Protection and Energy Maanshan Iron & Steel Co. Ltd

2022 4 A#  
2#3#4#

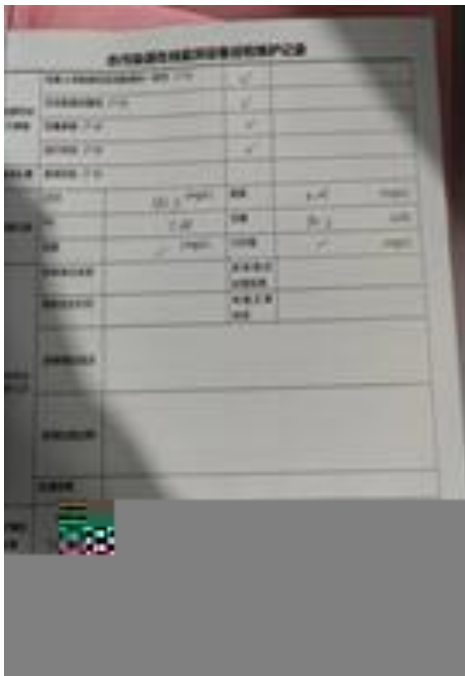
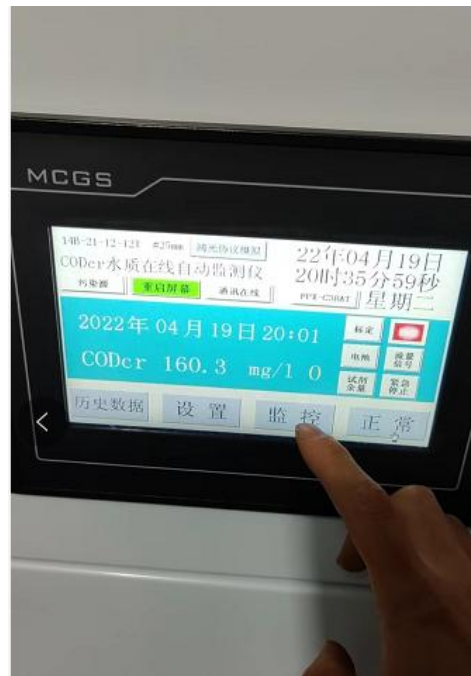
2022 4 19 -4 20  
 (CODcr) 19 70.982 mg/L 20 148.195  
 mg/L COD 72  
 COD
